Landslides and related features interpreted from aerial photographs:

LANDSLIDES AND RELATED FEATURES

OF THE WIBORG, KY. QUADRANGLE

U.S. Geological Survey
OPEN FILE MAP 82-653 (6-13)

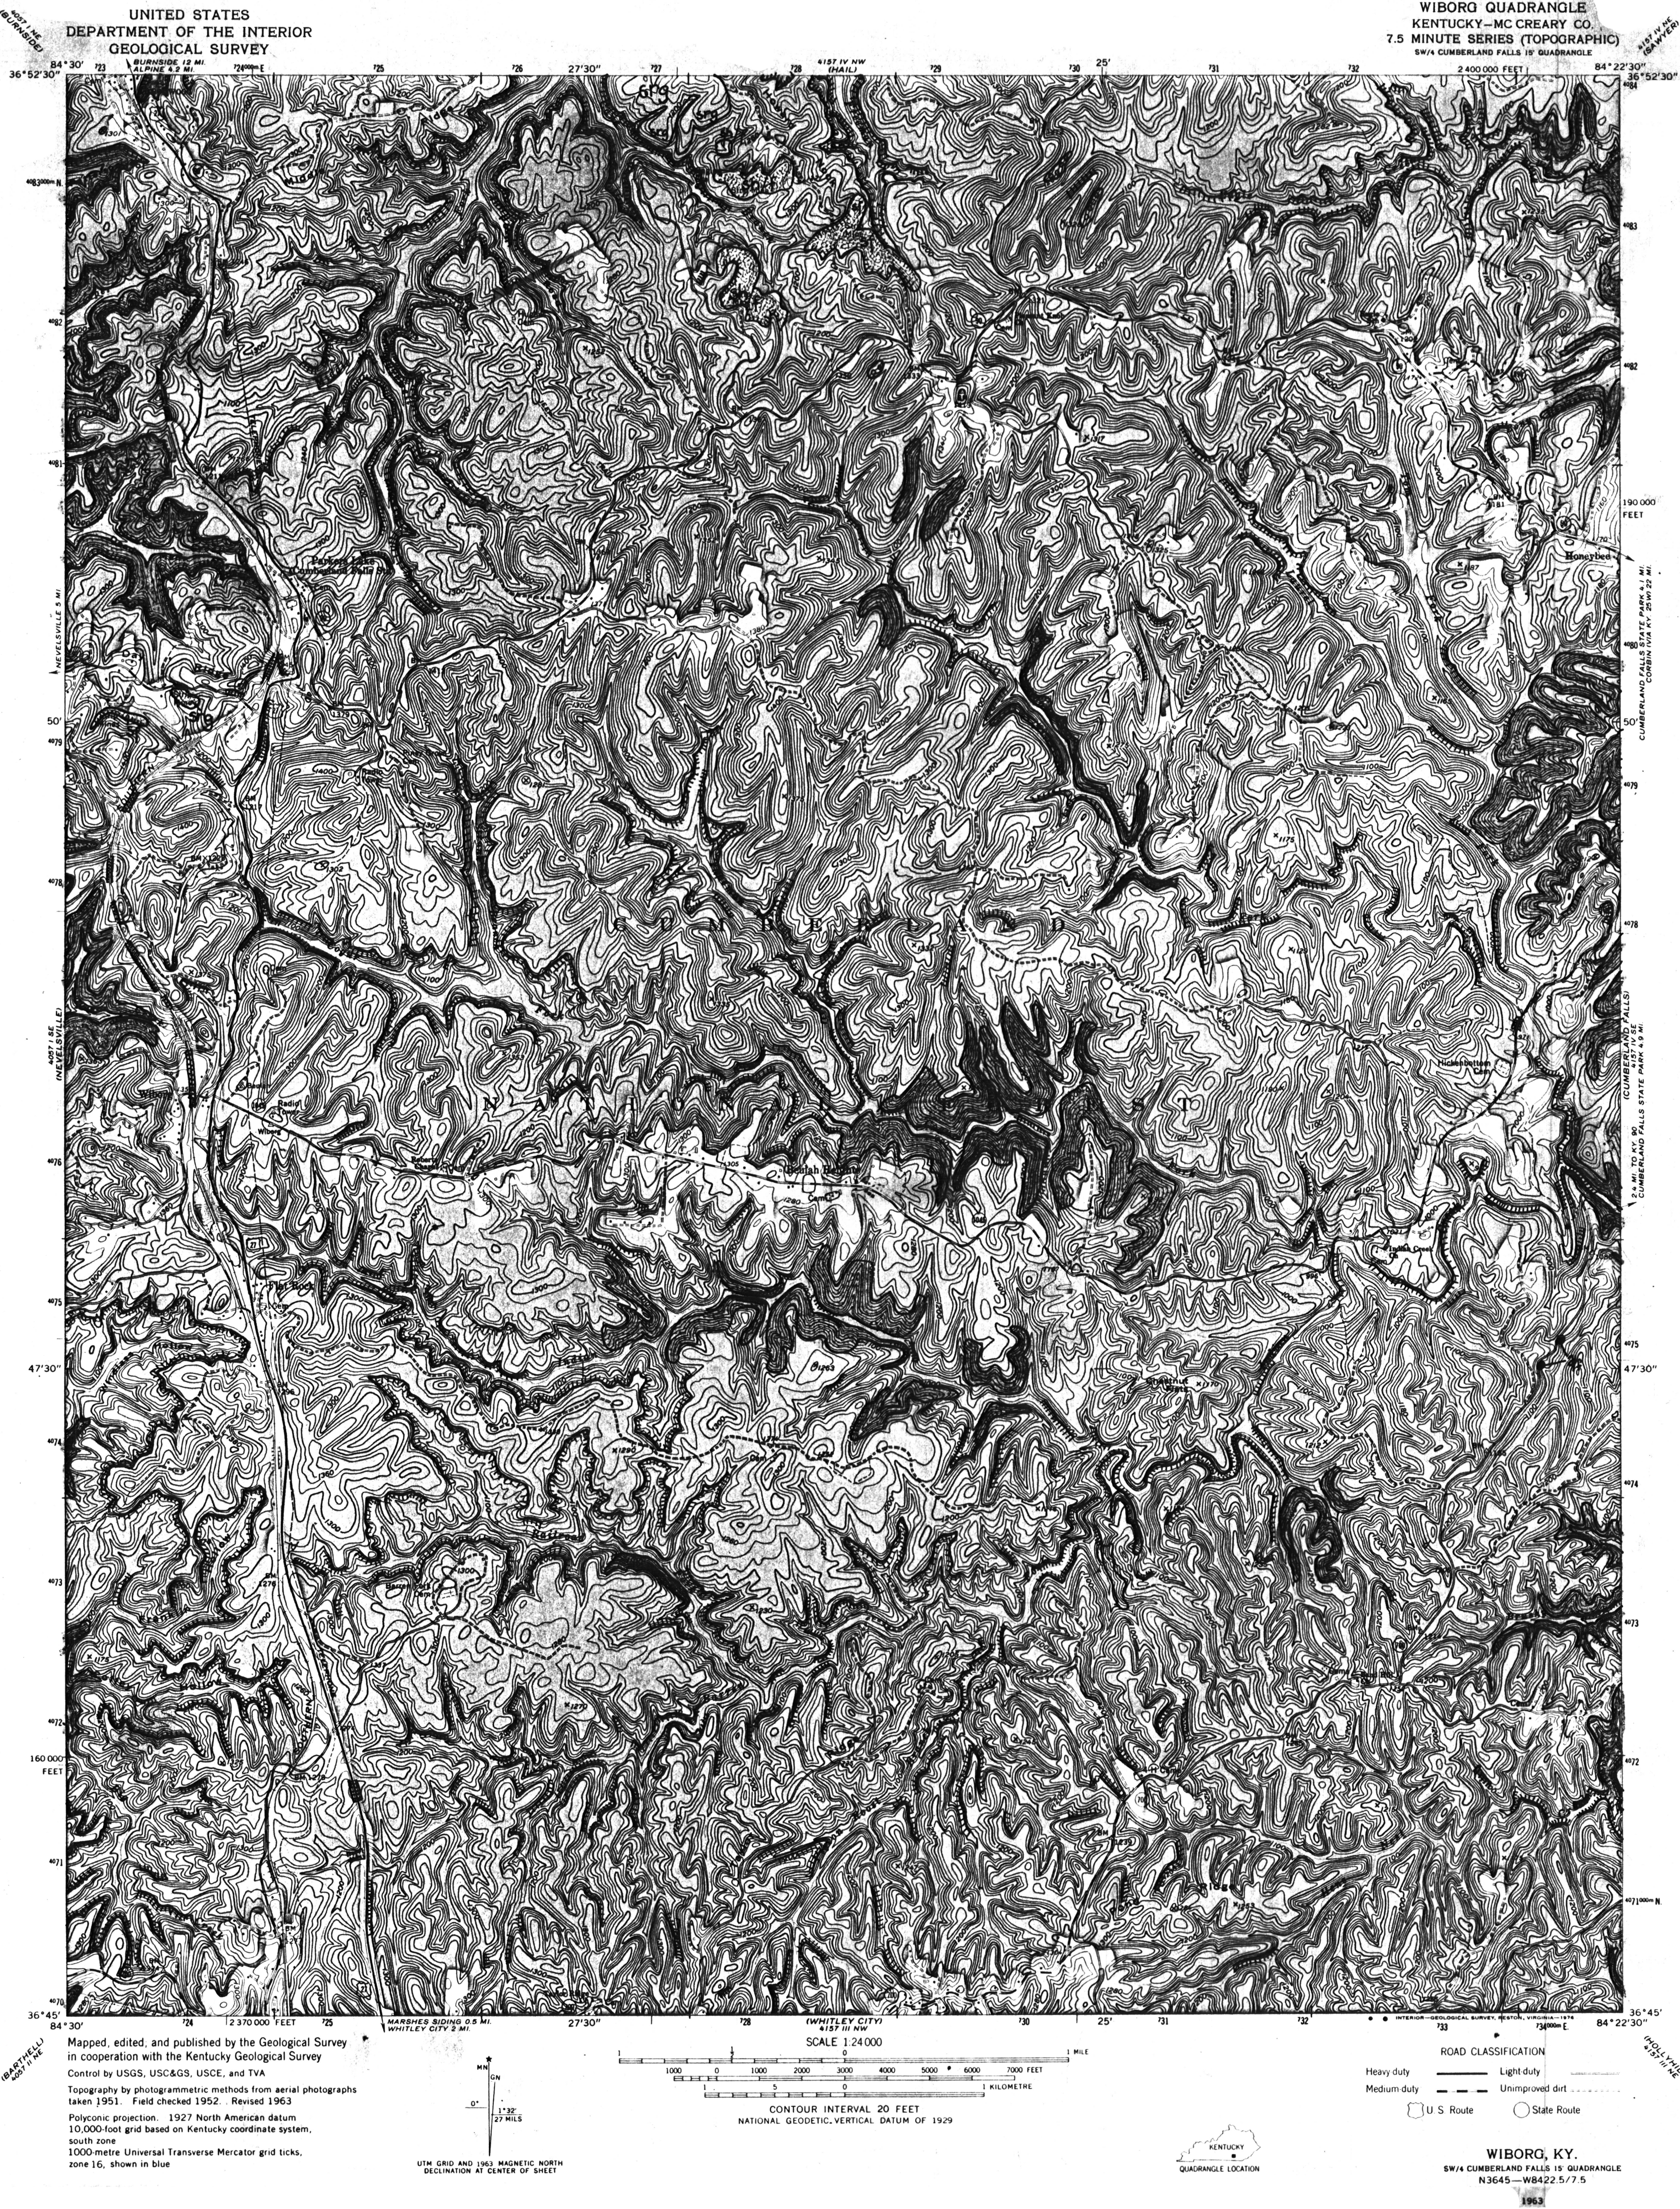
ACTIVE OR RECENTLY ACTIVE LANDSLIDE
Complex landslide composed of earthflow, debris slide, earth and rock slump. Identified from historical records, and from scars, debris and other field evidence. Ground extremely unstable; sliding accelerated by excavation, loading and changes in drainage conditions. May include areas with several active slides too small to be shown separately. Questioned where doubtful.

OLD LANDSLIDE
Area of extensive hummocky ground caused by earthflow and earth and rock slump. Lacks clear evidence of active sliding. Relatively stable in natural, undisturbed state, generally not affected by small structures properly sited in areas away from the edge of the toe; can be reactivated by extensive, rapid excavation, loading, and changes in ground water and surface water conditions. Area of old landslide probably includes recent ones not identified from field evidence or otherwise documented. Upslope boundary of landslide generally defined by modified scarp, but downslope (toe) may be gradational and not well defined. Questioned where doubtful.

COMBINATION LANDSLIDE
Area of recent and old slides in which individual slides are not identified.

COLLUVIAL SLOPE
Valley wall along major streams with slope as steep as 40° (85%); stony, clayey silt soil up to 50 ft. (15 m) thick; commonly buttressed by a terrace or bench at the toe of the slope; very susceptible to sliding by cutting of toe area, removal of terrace or bench, and overloading; slide commonly activated without apparent cause.

COLLUVIAL SLOPES WITH LANDSLIDES
Landslides too small or obscure to map individually.

AREAS SUSCEPTIBLE TO DEBRIS FLOWS AND DEBRIS AVALANCHES
Primarily shallow, narrow ravines and chutes with accumulation of stony colluvium generally 10 ft. (3 m) or less in thickness; susceptible to rapid movement during intense rainfall. Most ravines and chutes designated show evidence of former debris flows and avalanches.

AREAS SUSCEPTIBLE TO ROCKFALL
Steep, locally vertical, natural and man-made slopes and cliffs, 15 ft. (4.5 m) or more high; formed dominantly of sandstone, limestone, sandy shale, mudstone and claystone. Interbedded mudstone, claystone and shale weather rapidly leaving sandstone and limestone rock faces unsupported.

SOIL AND ROCK SUSCEPTIBLE TO LANDSLIDING
Soil and rock similar to that involved in landslides elsewhere in map area; primarily areas underlain by claystone, mudstone and shale associated with other rock types. Rock weathers rapidly on exposure forming clayey soil highly susceptible to sliding. Includes coves (U-shaped, shallow valleys) containing thick layers of clayey soil that are very susceptible to sliding where excavation breaks continuity of slope and where overloaded by artificial fill.

AREAS LEAST PRONE TO LANDSLIDES
Map areas in which no patterns or symbols are shown; primarily valley floors, ridge tops and broad benches; modification by excavation and fill may lead to local landslides.
